Manhole Inspection Summary

Manhole # S41WW_013MH

Insp Date: **2/23/07 10:27 AM**

Location Address: **1302 LOCH RAVEN RD**

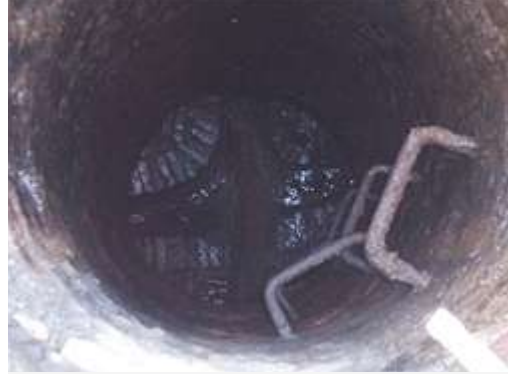
Top View

☒ **Debris** (not Condition related)

☒ **Corroded**

Corroded steps. Bench and Channel debris.

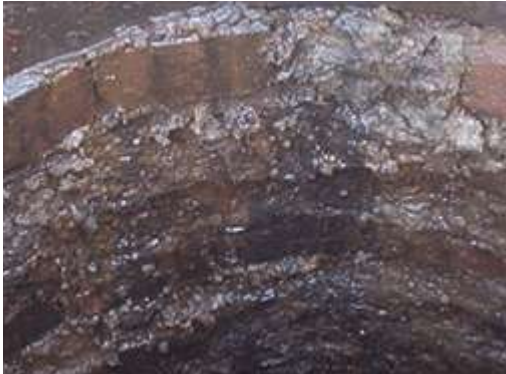
Defect

☒ **Leaks**

Condition: ☐ Sound ☐ Cracked ☐ Root Intrusion ☐ Loose Brick ☒ **Deteriorated**

Infiltration: ☐ None ☐ Joint ☐ Cracks ☐ Mortar ☐ Roots ☒ **Wall**

Frame leaks. Adjustment deterioration and infiltration.

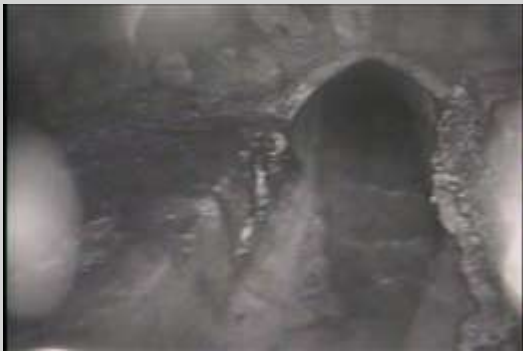
8 in. Circular Gravity Sewer Pipe In @ 3 O'Clock

Deposits: ☐ None ☐ Mud ☐ Sludge ☐ Debris ☒ Grease

Silt Depth: **0** (in.) Deposits Extent: **Light**

Infiltration: **None** Pipe Seal Cond: **Broken**

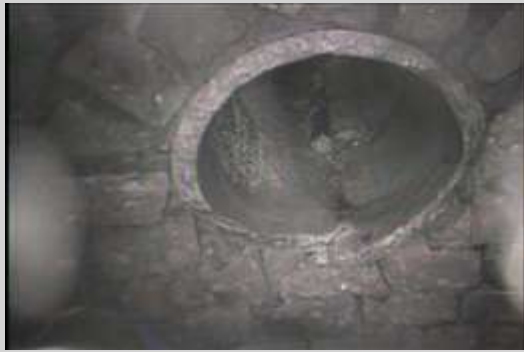
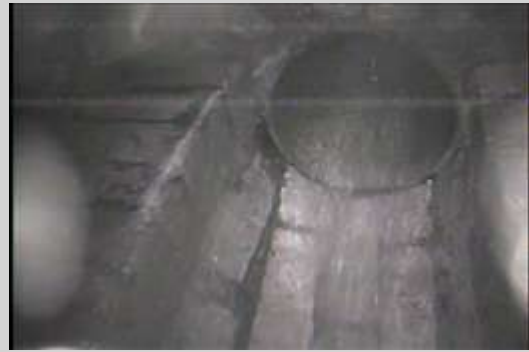
Pipe In @ 6 O'Clock

Infiltration: **Evidence** Pipe Seal Cond: **Unknown**
